Pedestrian Crossing Safety

2017 Toward Zero Deaths Conference
Oct. 26–29, 2017

Kristi M. Sebastian, P.E., PTOE
Dakota County

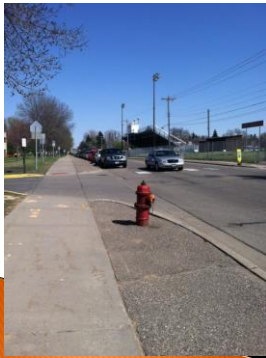
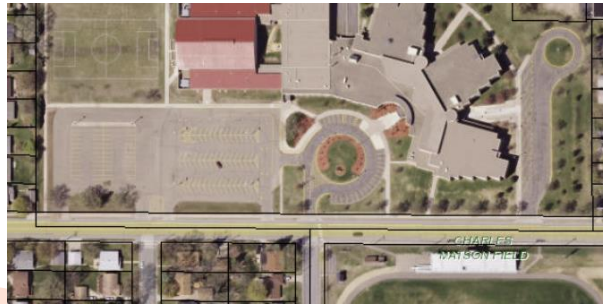
Heritage Middle School Project

County Rd. 6, Butler Avenue in WSP

- ▶ Issue – Problematic parent pick-up process, Parked cars creating safety issue, multiple access points.

- ▶ New Mid-Block Crossing with Pedestrian Bump Out
- ▶ Removal of access and lot reconfiguration to accommodate parent's drop-off / pick-up of student's in safer more effective manner
- ▶ Turn lane for the main school access
- ▶ School Crossing Guards
- ▶ Parent information sent to describe crossing and student pick-up process

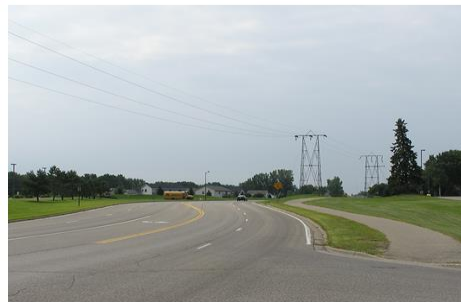
County Highway 33 and 145th *Apple Valley and Rosemount*

- ▶ Issue: Unmarked intersection along high Speed Roadway near school with desired pedestrian crossing activity between residential area and school/park facilities.

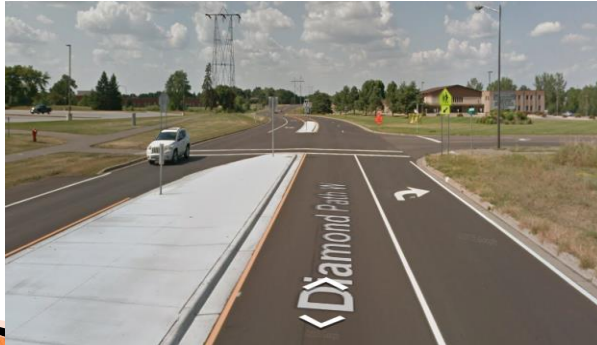
County Hwy 33 and 145th

- ▶ Action: Modify Roadway configuration to *creating a pedestrian refuge and fewer traffic conflict points.*

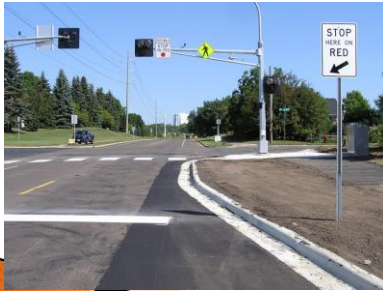
County Highway 11 and Evergreen

- ▶ Action: *Installation of the “HAWK” and curb bump-out to lessen crossing distance. Plus, educational information and collaboration with school.*

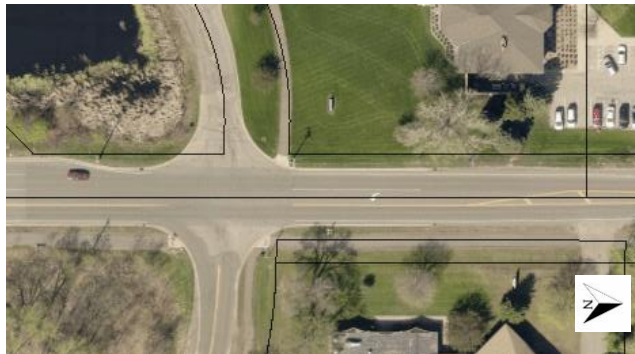
County Road 43 and Victoria Road in Mendota Heights

- ▶ Issue: *Busy pedestrian area with request for crosswalk markings.*

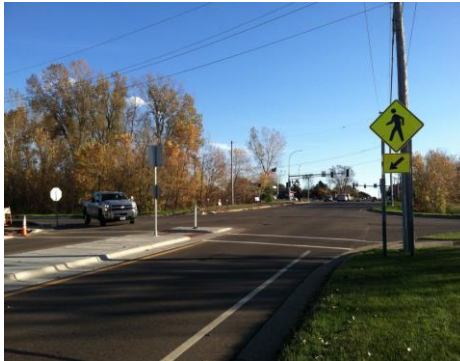
County Road 43 and Victoria Road

- ▶ Removed turn lane to create median area for separating movements and enhancing the crossing.

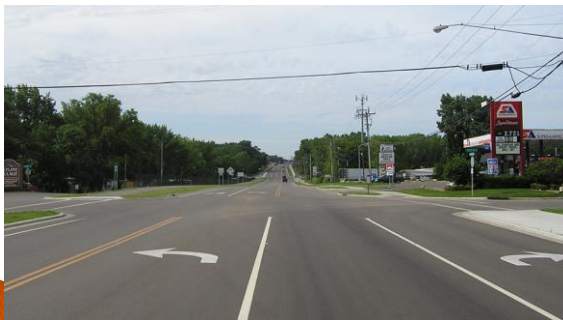
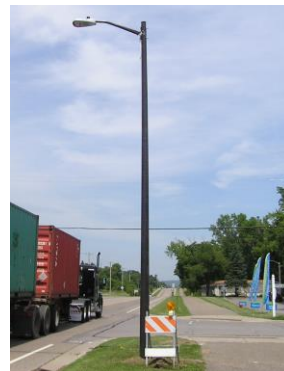
Concord (Hwy 56) & 75th street in Inver Grove Heights

- ▶ Issue: High level of pedestrian activity. Three Lanes – no median. High Speed Roadway.
- ▶ Action: Ped ramps and lighting – No Markings
