TZD East Central Workshop

Collision Reconstruction

Case Study

24601973

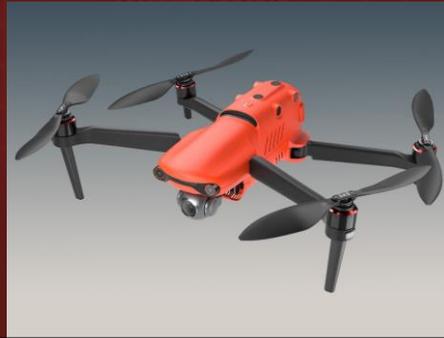
- **Small Unmanned Aerial System (sUAS)**
 - Greatly decreases on-scene time compared to traditional equipment
 - Enhances open road policy and safety of LE and public
 - Uses photographs and videos generated from on-scene flights and special software programs to create a scaled forensic map.
 - Members are FAA Part 107 pilots

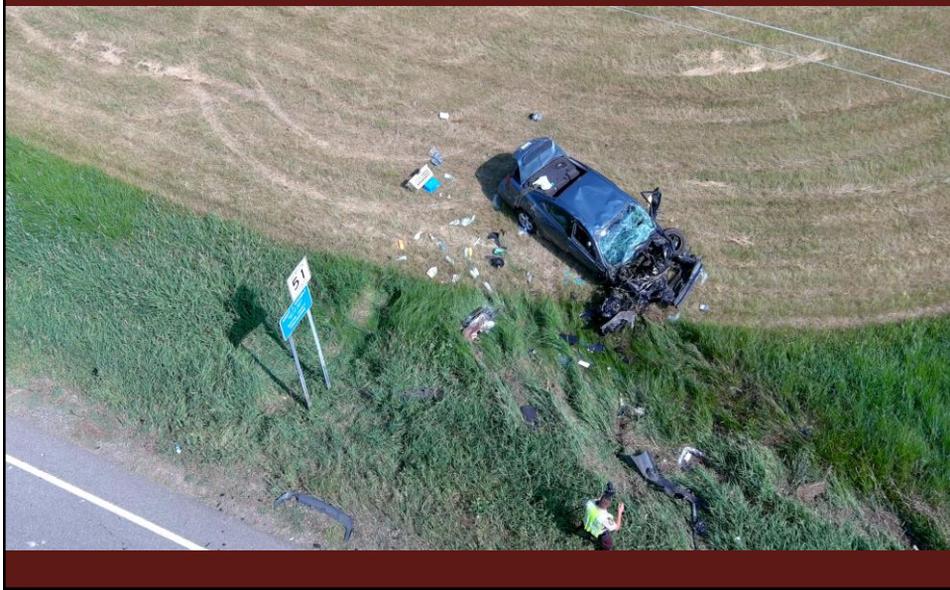
sUAS Forensic Mapping

Minnesota State Patrol Forensic Map	Location 10252 Highway 55 Annandale, MN	Control # 23603023	Drawn By T/Sgt. Kylie Backer
	Principles Scott William Lampi, DOB 08/29/1956	Date of Collision August 11, 2023	Primary Investigator Ttp. John Schmutzer

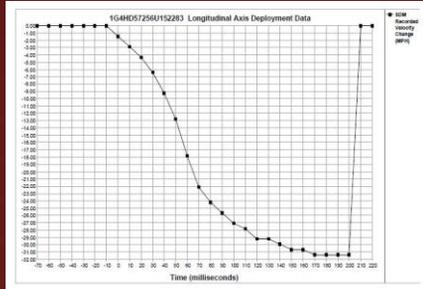
Airbag Control Module

Pre-Crash Data (Most Recent Event - table 2 of 4)
 (the most recent sampled values are recorded prior to the event)

Time Stamp (sec)	Steering Input (deg)	Raw Manifold Pressure (kPa)	ECM ML	Yaw Rate (deg/sec)	Wheel Speed, LF (RPM)	Wheel Speed, RF (RPM)	Wheel Speed, LR (RPM)	Wheel Speed, RR (RPM)
-5.0	-2	18	Off	1	551	514	507	564
-4.9	-2	18	Off	1	539	511	601	549
-4.8	-3	18	Off	2	519	506	566	527
-4.7	-4	18	Off	2	500	506	595	515
-4.6	-5	20	Off	2	496	506	589	499
-4.5	-7	22	Off	3	468	504	595	456
-4.4	-10	26	Off	4	452	599	576	477
-4.3	-13	29	Off	4	445	591	570	462
-4.2	-22	32	Off	5	442	571	562	456
-4.1	-33	36	Off	5	458	556	535	444
-4.0	-46	38	Off	5	498	626	500	419
-3.9	-49	42	Off	4	534	352	470	458
-3.8	-49	44	Off	5	560	292	440	397
-3.7	-55	40	Off	5	569	268	438	414
-3.6	-52	40	Off	6	591	210	415	409
-3.5	-71	43	Off	7	569	245	371	373
-3.4	-83	42	Off	6	519	250	383	390
-3.3	-94	35	Off	10	498	211	383	395
-3.2	-103	30	Off	13	503	297	375	387
-3.1	-111	26	Off	15	505	263	372	387
-3.0	-118	23	Off	17	496	384	369	384
-2.9	-125	22	Off	20	454	388	363	375

Parameter	-2.5 sec	-2.0 sec	-1.5 sec	-1.0 sec	-0.5 sec
Accelerator Pedal Position (percent)	79	79	79	88	100
Vehicle Speed (MPH)	57	58	60	62	66
Engine Speed (RPM)	3520	3584	3648	3712	4032
Percent Throttle	89	89	89	97	100
Brake Switch Circuit State	OFF	OFF	OFF	OFF	OFF

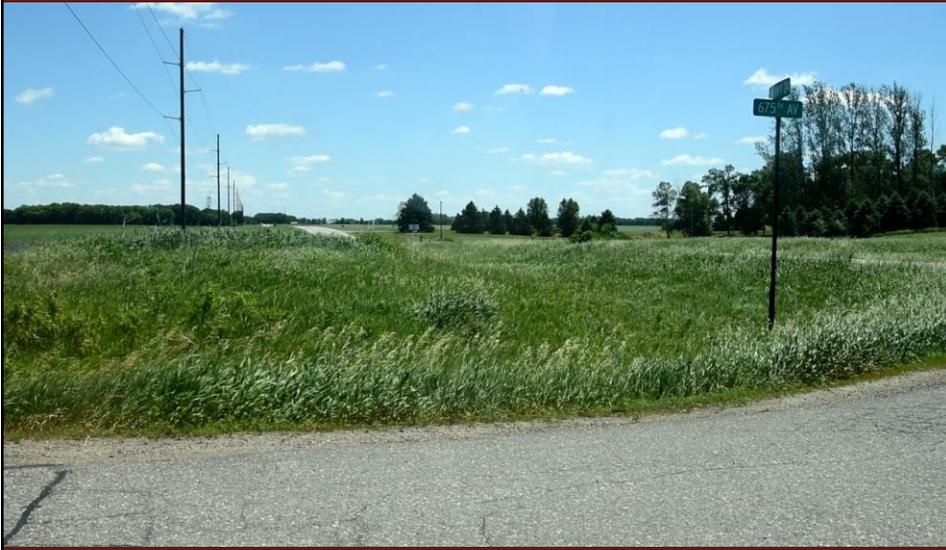
24601973

- Engineering and Environmental Investigation
 - NOAA Solar Calculator (Sun position was not a factor)
- Roadway Engineering
 - A visibility study was conducted.
 - The study revealed a raised berm and tall grass in NE corner of intersection created a clear line of sight obstruction.
 - The obstruction occurred when a vehicle traveling west on State Highway 24 was approximately 600 feet east of the intersection.
 - A vehicle traveling west on State Highway 24 would not be visible for approximately one second to a vehicle legally stopped at the stop sign on 675th Ave.

- Engineering and Environmental Investigation
 - Met with MnDOT traffic engineer John Hager to conduct a field review of the intersection.
 - Field review obtained a sight distance using MnDOT road design manual processes.
 - The calculated minimum sight distance value at 55mph for a passenger car is 607 feet.
 - We obtained a sight distance much greater than the required distance but it did not accurately reflect the conditions of the crash due to a recent mowing of the grass in the ditch.
